**DEPARTMENT OF TRANSPORTATION**

Contract #: 04-0120F4Cty: SF/ALA Rte: 80 PM: 13.2/13.9File #: 69.28**WELDING INSPECTION REPORT****Resident Engineer:**Siegenthaler, Peter**Address:** 333 Burma Road**City:** Oakland, CA 94607**Report No:** WIR-019325**Date Inspected:** 09-Jan-2011**Project Name:** SAS Superstructure**OSM Arrival Time:** 700**Prime Contractor:** American Bridge/Fluor Enterprises, a JV**OSM Departure Time:** 1900**Contractor:** Zhenhua Port Machinery Company, Ltd (ZPMC), Changxing Island **Location:** Shanghai,China**CWI Name:** Lv Li Qing**CWI Present:** Yes No**Inspected CWI report:** Yes No N/A**Rod Oven in Use:** Yes No N/A**Electrode to specification:** Yes No N/A**Weld Procedures Followed:** Yes No N/A**Qualified Welders:** Yes No N/A**Verified Joint Fit-up:** Yes No N/A**Approved Drawings:** Yes No N/A**Approved WPS:** Yes No N/A**Delayed / Cancelled:** Yes No N/A**Bridge No:** 34-0006**Component:** OBG**Summary of Items Observed:**

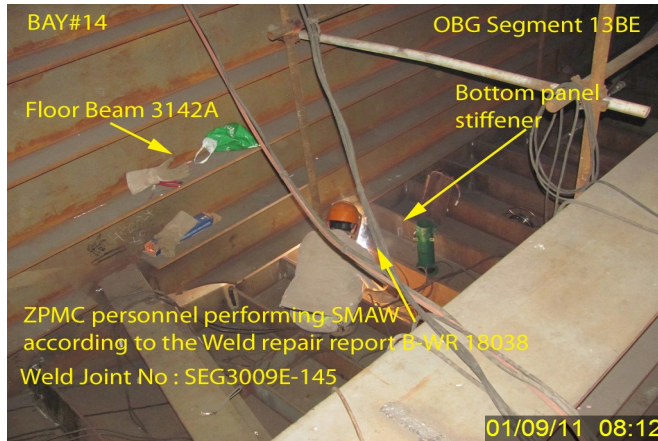
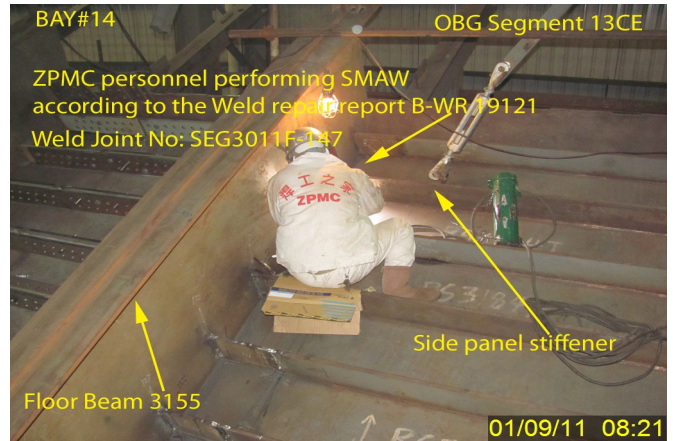
SMAW welding of weld joint no: SEG3009E-145 located on OBG Segment 13BE Bottom plate stiffener to Bottom plate stiffener. Welder is identified as #048047. ZPMC CWI is identified as Mr. Cheng Xi. Welding was performed according to the weld repair report B-WR18038.The welding variables recorded by QC appeared to comply with the WPS-345-SMAW-3G(3F)-FCM-Repair-1. Please see the attached picture.
